The Narraport Hut

Report on the future of the Narraport Shepherds' hut built c.1847.

This report was prepared by students of the Birchip Community Education Complex as part of their year 9 history studies of the Squatting era, under the guidance of their teacher, Mr. Iain Atkin

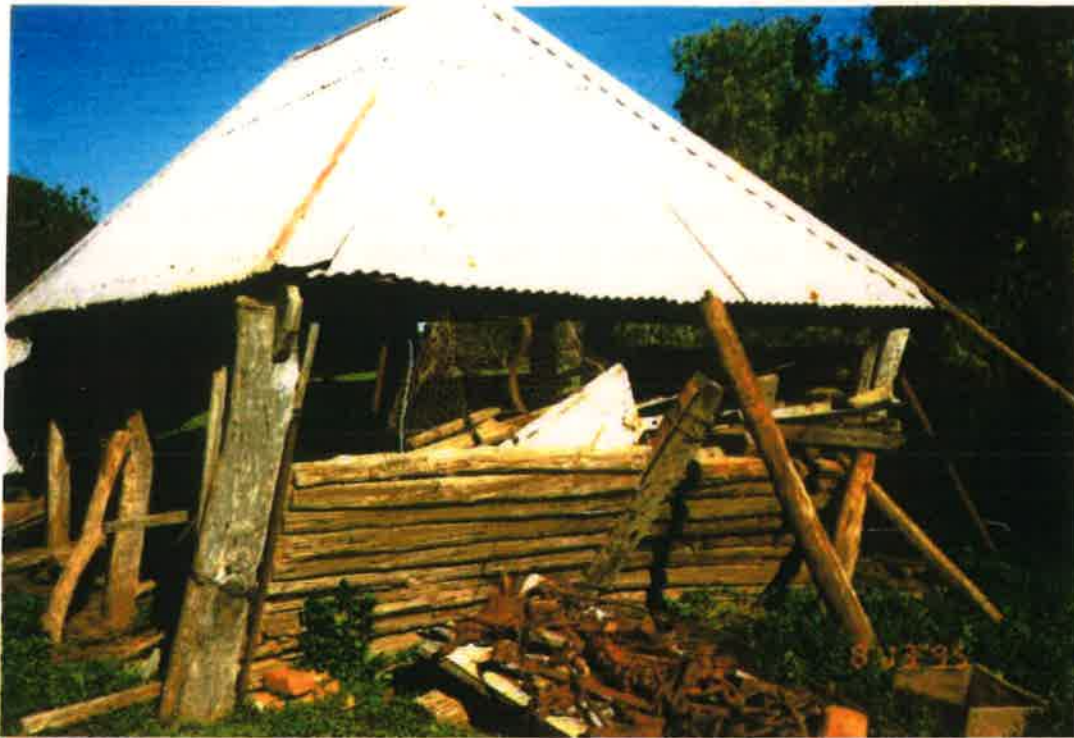
The students were driven out to the site and started to clean up the inside of the hut and the surrounds, as can be seen the hut was not only in a parlous state of repair, it was full of junk.

The students made decisions as to what should be kept under cover and preserved (such as pieces of the original timber of the hut and artefacts that might have some value or relevance) and what should be discarded. The cleared site was then inspected and the students started to investigate their particular aspect.

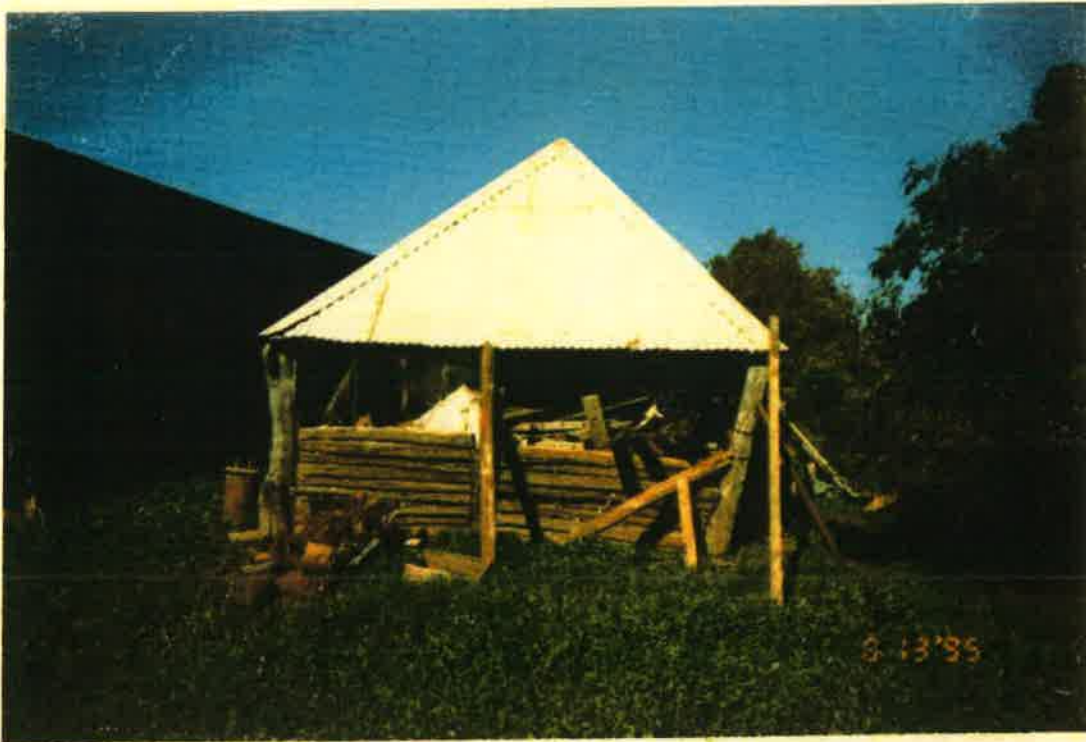
The hut is constructed out of Murray Pine and Box Eucalypt. Murray Pine is termite-resistant, light and durable. It was easily available from a large forest near Wooranook Lakes. There were several saw mills in the forest which is no longer there, attesting to the popularity of the timber for similar constructions when the hut was being built. This timber was used to make horizontal logs walls of the hut. There were over sixty original logs, most still in position, although some had split.

These photographs show the two original poles on the north side of the hut. They also show clearly the horizontal Murray Pine logs.

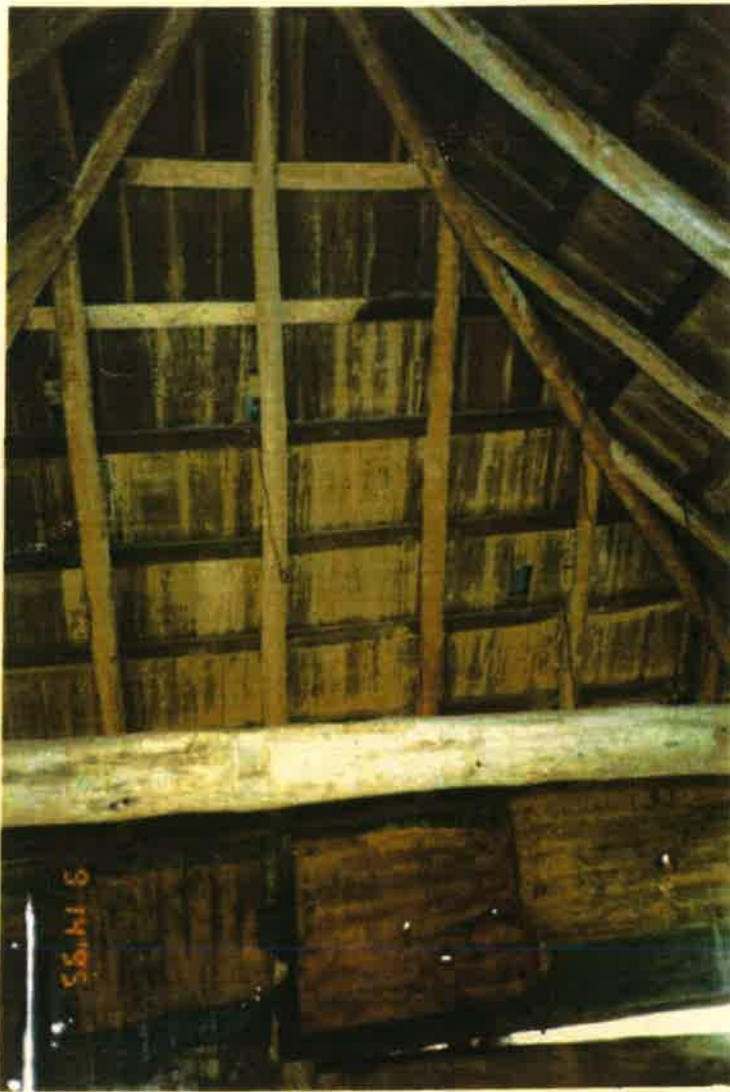
The hut is roofed by shingles which were attached to the battens by handmade nails. These shingles have been covered at a later date by corrugated iron, which has been screwed on to battens. This covering has no doubt lead to the excellent state of the roof, and hence allowing the rest of the hut to be preserved.

Photograph showing interior of roof with the shingles under the tin.

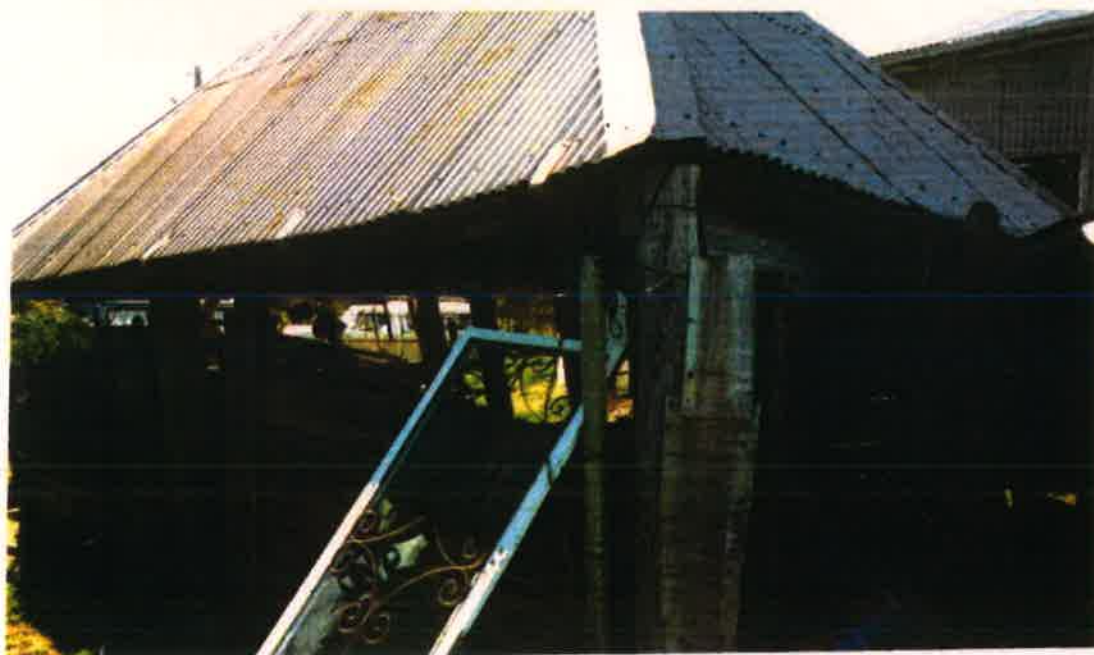
Although no evidence can be found to determine why there is no spouting on the west side of the hut, no logical reason can be thought of as to why it would not have originally been there. It was originally attached to the uprights with blocks of oregon with a semi-circular groove cut into the top attached to the uprights. These again can be seen in the photograph of the east wall showing the railway sleepers and two were still found nailed to the uprights. One was also found when we cleaned out the hut. Elsewhere, strips of tin have been screwed on to the roof to hold the spouting up, which would have taken the place of the oregon as it rotted.

Photograph showing replacement strips of tin used to hold up spouting.

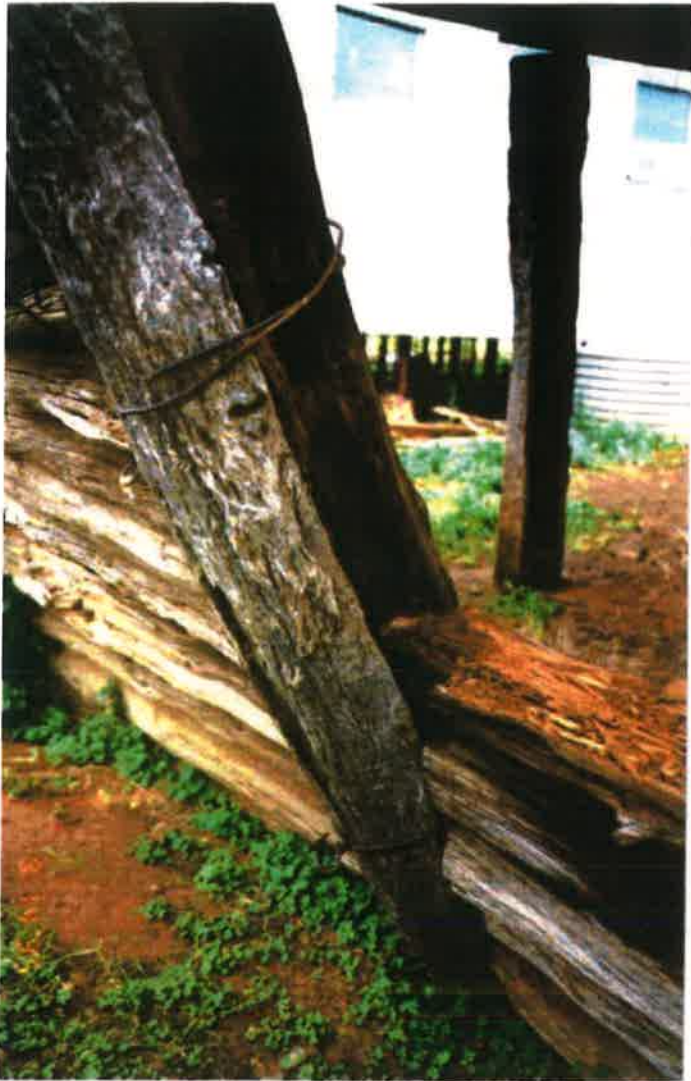
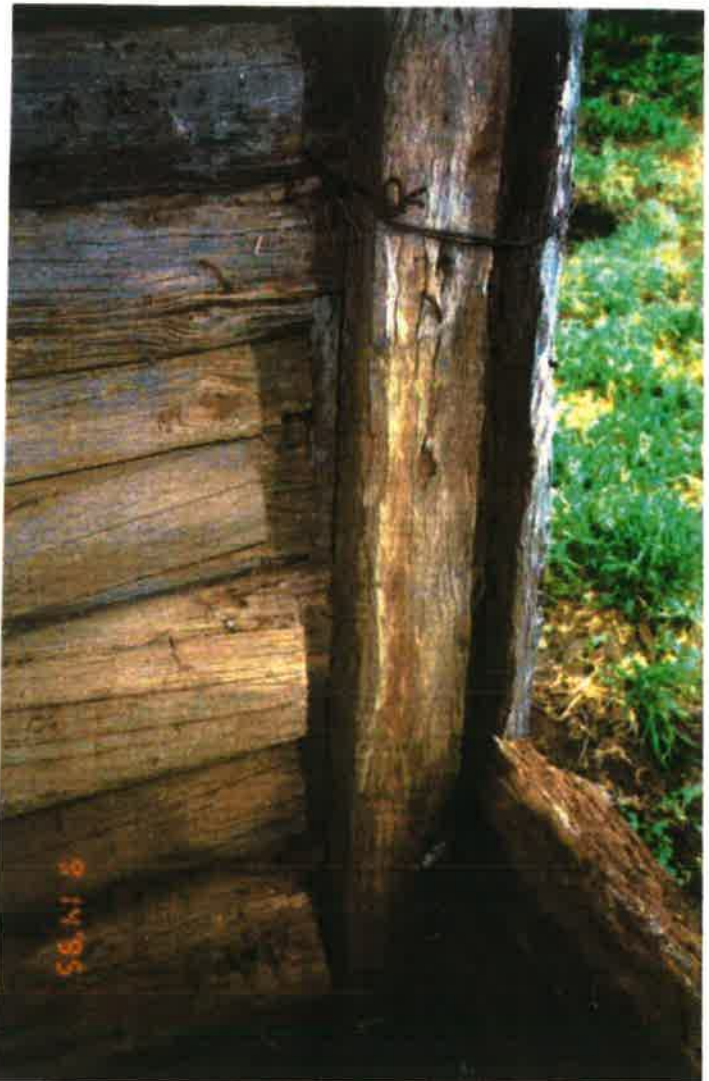
The hut walls were built using the unusual construction called the 'drop-slot' method - most huts from this time being made of vertical slabs of log fitting into a slot on the top and bottom plates. The drop-slot construction is still clearly shown on the hut today where the horizontal logs fit into a slot cut into the uprights. These slots were cut by boring holes approximately four centimetres deep in a line along the length of the upright. These were then chiselled out and a slot or trench ensuing. The marks from the brace-and-bit can still be seen in the original slots.

Close-up of two of the original posts, showing several circular marks from the bit used to cut the slot and the "drop-slot" method of attaching the logs to the uprights.

The horizontal logs were sawn to form a tongue which fitted into the slot. All the logs show this type of construction. Many cracks existed throughout the walls of the hut. These had been filled with mud to block out wind or rain, some of which still remains.
